June 28, 2019
File No. 262018.063

Subject: Department of Natural Resources Washington Geological Survey,
School Seismic Safety Assessment Project, Contract No. AE 410 -
Seismic Evaluation for **Naches Valley School District**

Naches Valley, Naches Valley High School, Gym Building

Naches Valley, Naches Valley Middle School, Main Building

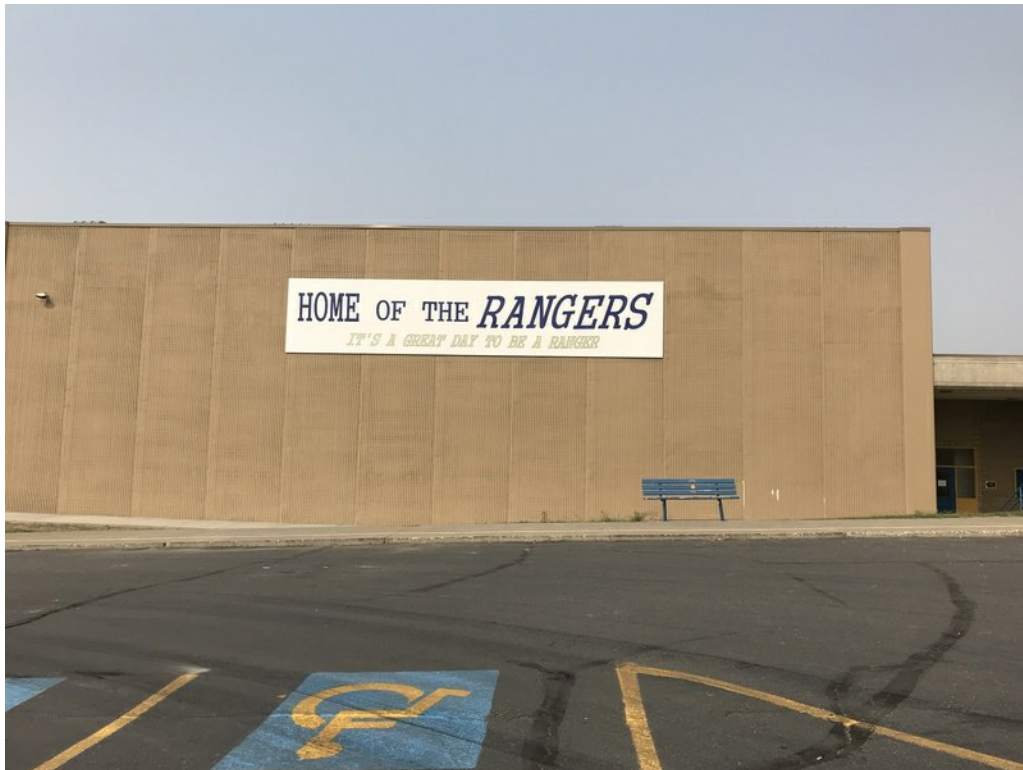
Figure 1-1. Naches Valley HS Gym

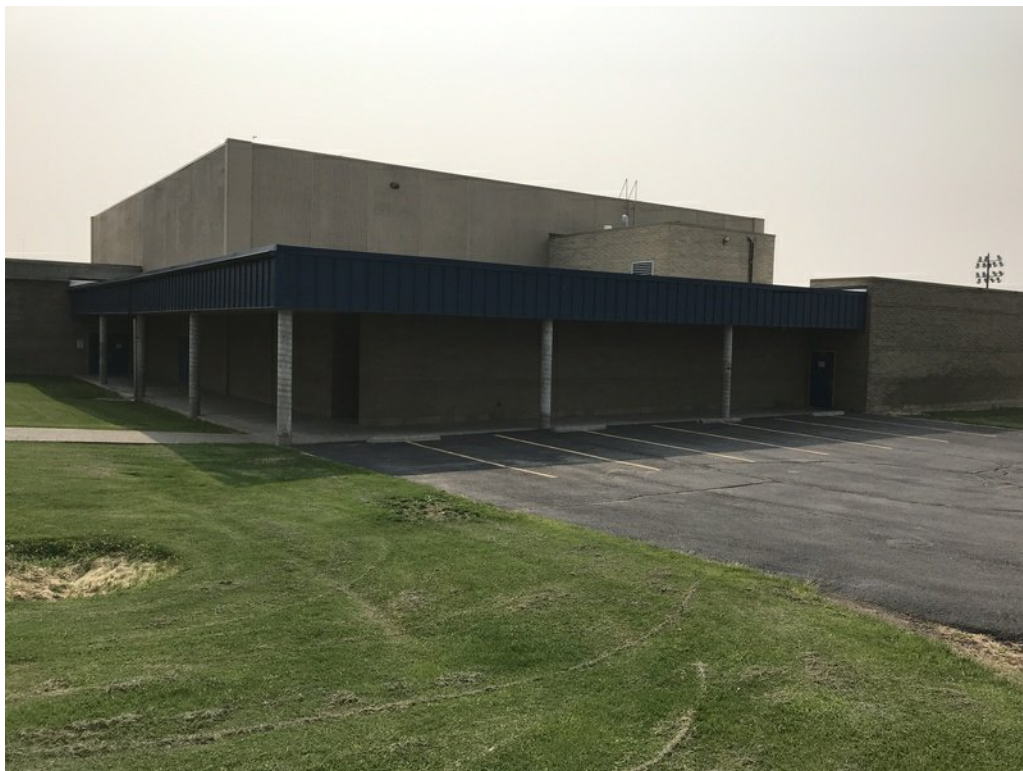
Figure 1-2. Naches Valley HS Gym

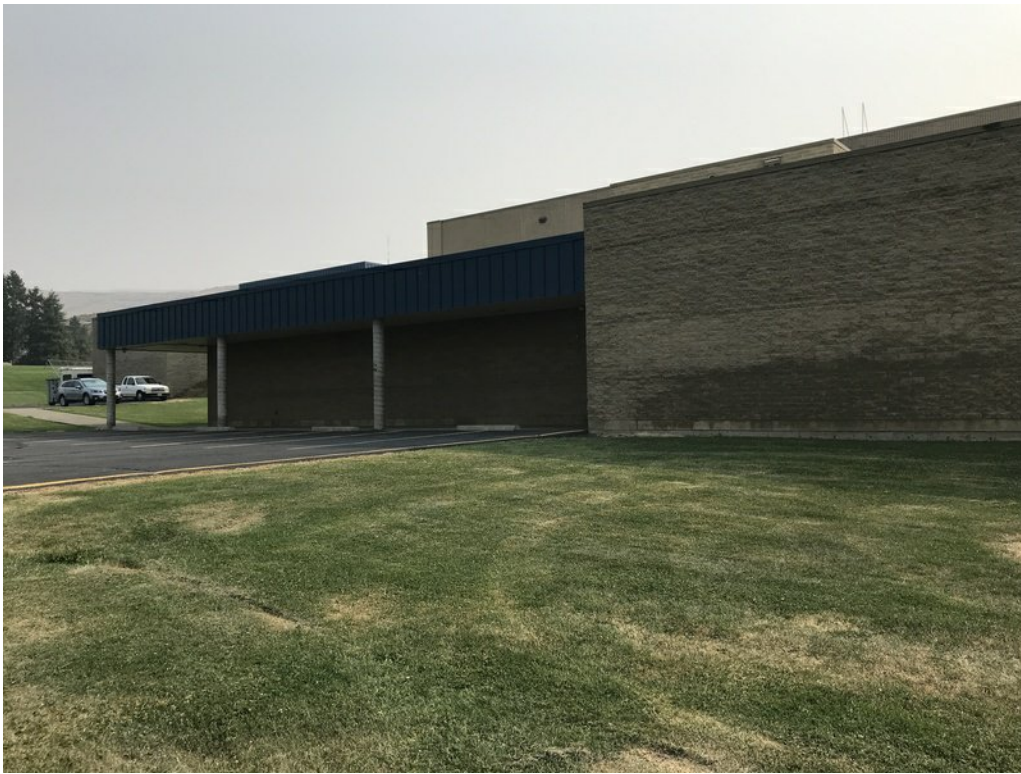
Figure 1-3. Naches Valley Gym

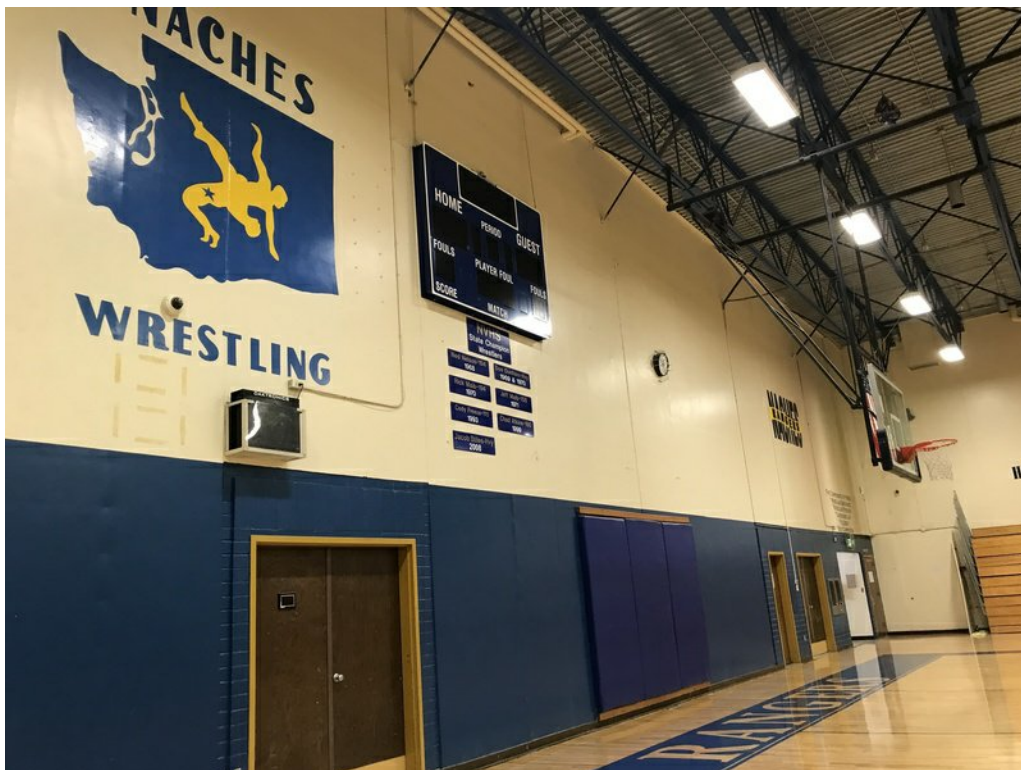
Figure 1-4. Naches Valley HS Gym

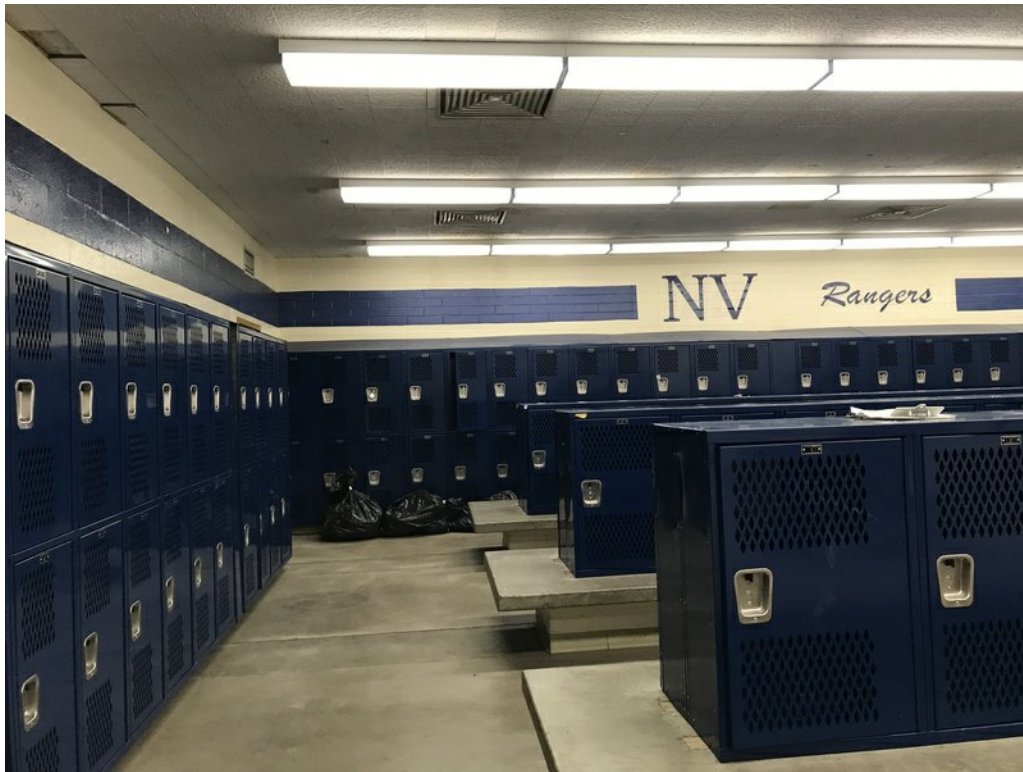
Figure 1-7. Naches Valley HS Locker Room

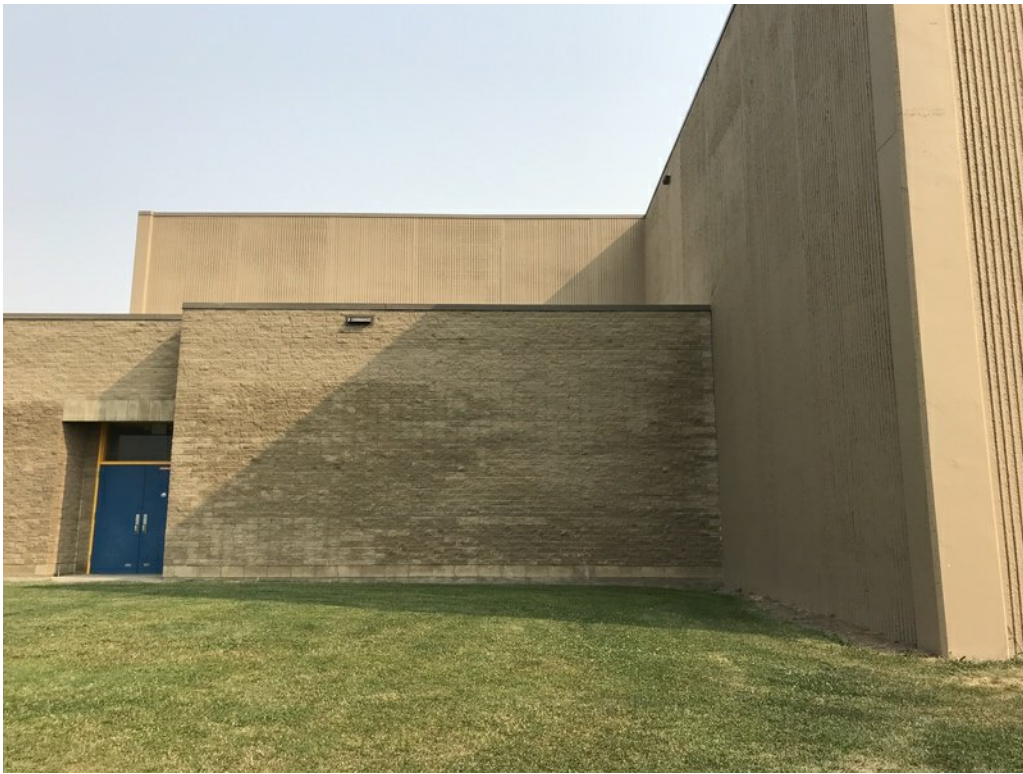
Figure 1-9. Naches Valley HS Gym/Locker Room

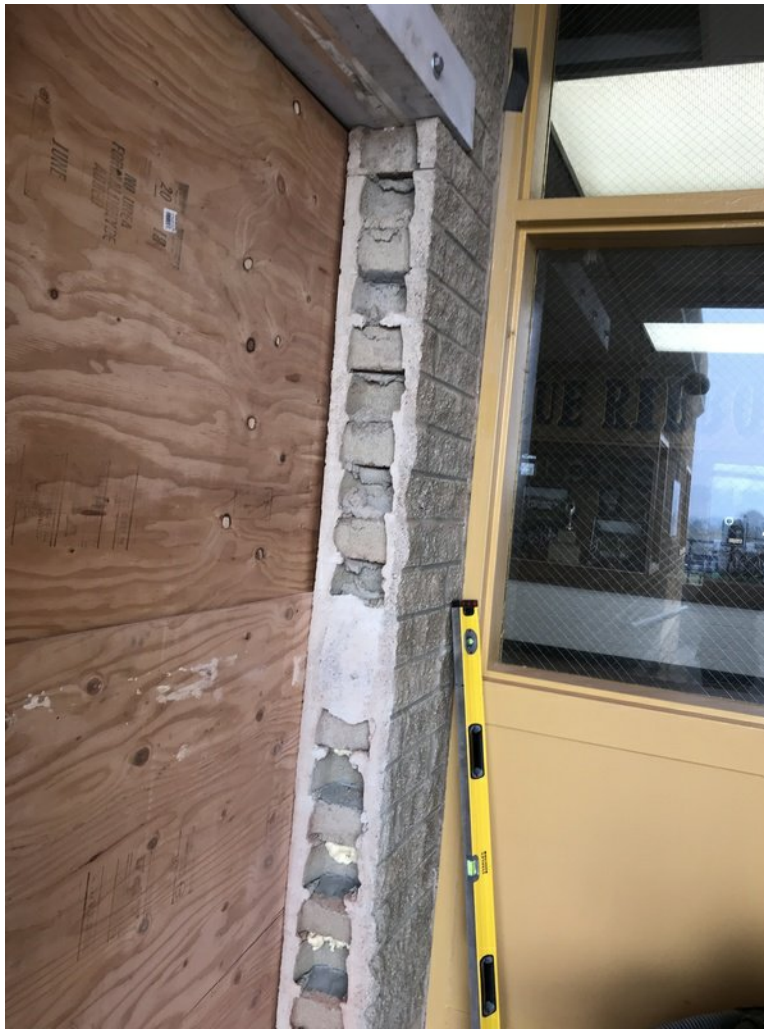
Figure 1-7. Naches Valley HS Classroom Bldg - new door opening exposes wall construction

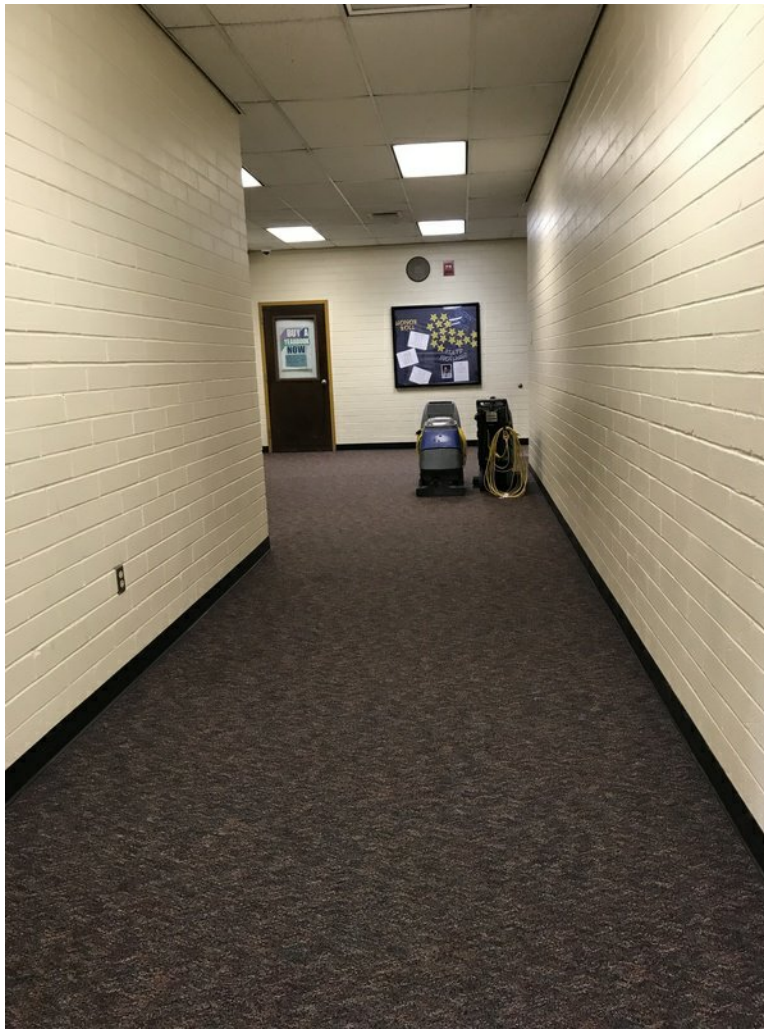
Figure 1-8. Naches Valley HS Classroom Bldg hallway (cmu construction)

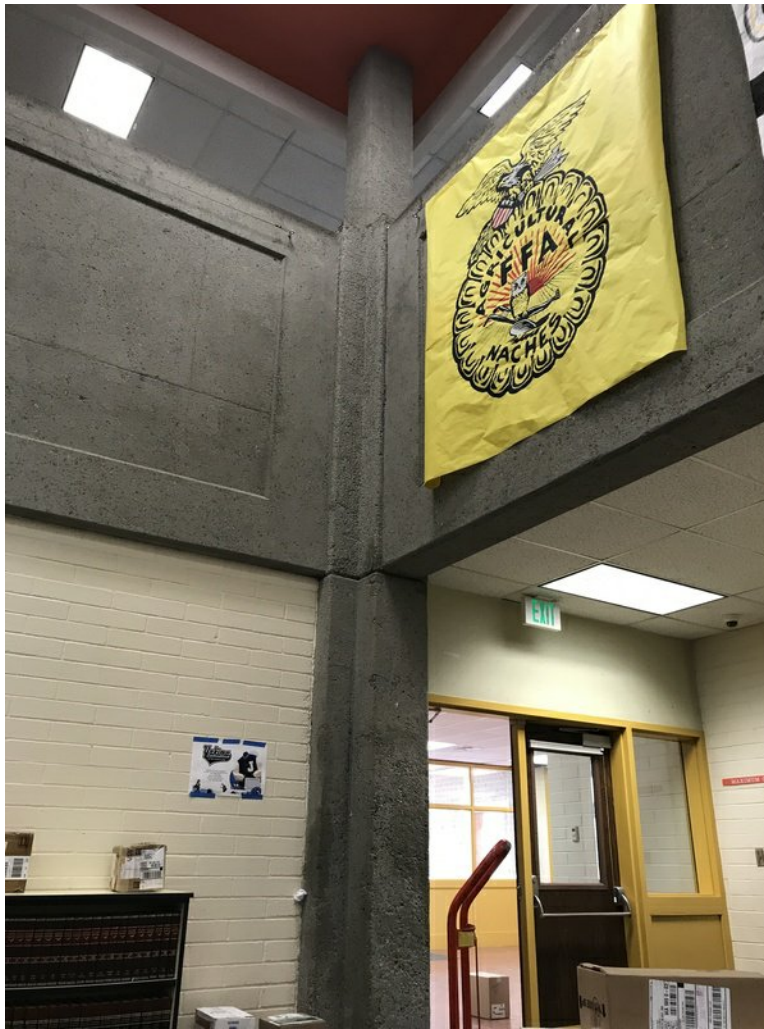
Figure 1-9. Two story construction - concrete beam supported on concrete column

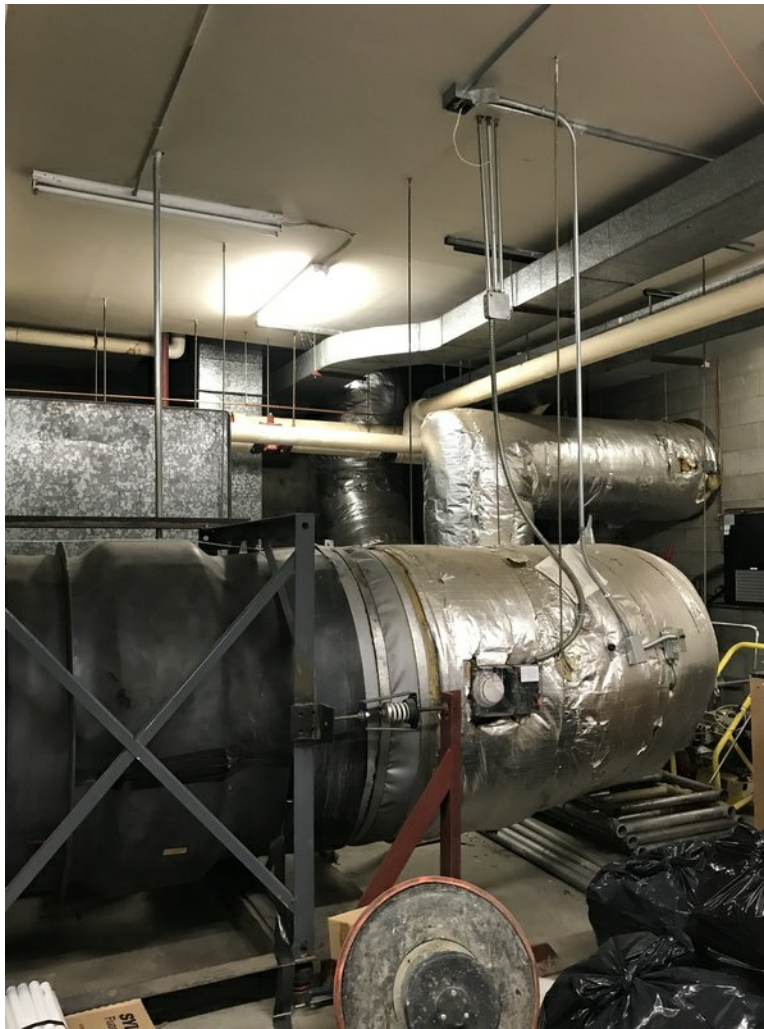
CF-3 Fall-Prone Contents. HR-not required; LS-H; PR-H.	Did not observe. District to confirm. Heavy items on upper shelves should be restrained by netting or cabling to avoid falling hazards.
ME-2 In-Line Equipment. HR-not required; LS-H; PR-H.	Mechanical room was exceptionally clean and well kept. Unclear if in-line equipment was braced as required. Bracing for heavy in-line equipment may be appropriate to mitigate seismic risk.
EL-1 Retainer Guards. HR-not required; LS-H; PR-H.	Details not available. Further investigation may be appropriate to mitigate seismic risk.
EL-2 Retainer Plate. HR-not required; LS-H; PR-H.	Details not available. Further investigation may be appropriate to mitigate seismic risk.

Figure 1-10. Classroom building mechanical space

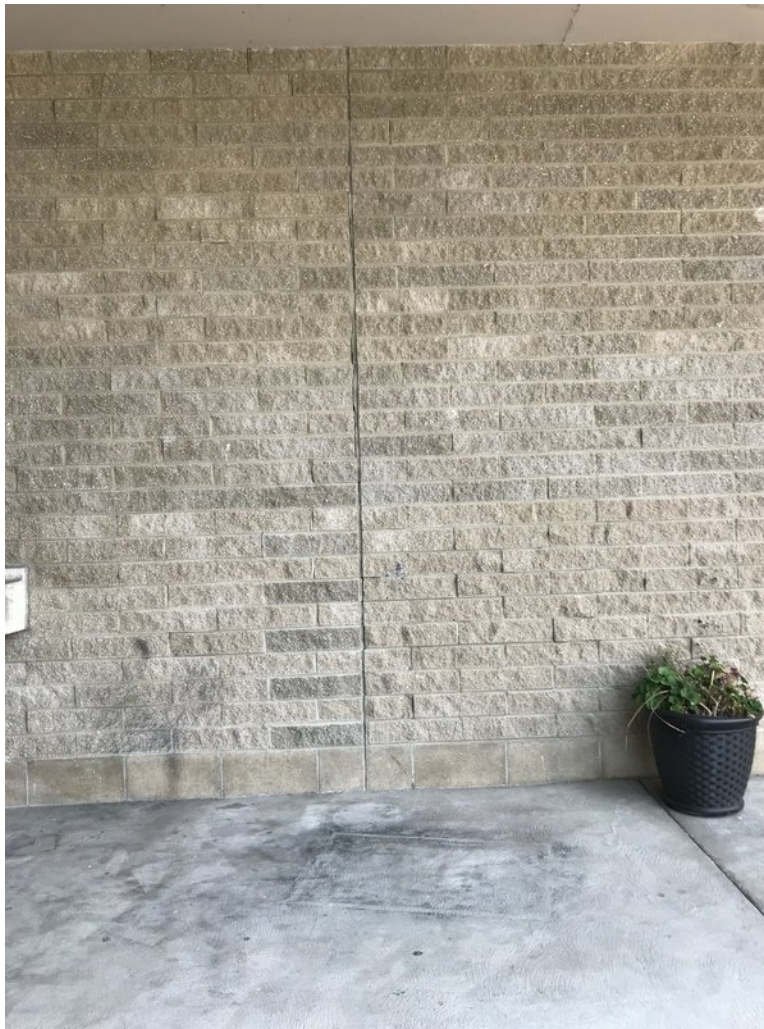
Figure 1-4. Naches Valley HS Voc Tech cmu control joint

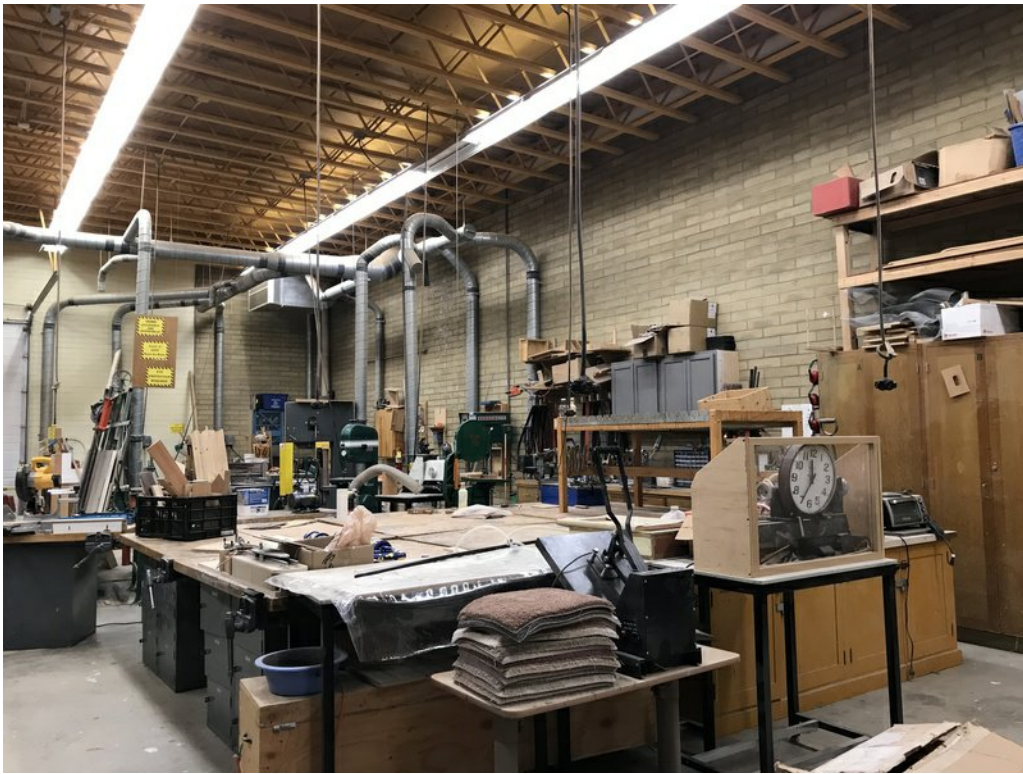
ME-2 In-Line Equipment. HR-not required; LS-H; PR-H.	District to confirm.
ME-3 Tall Narrow Equipment. HR-not required; LS-H; PR-MH.	There is heavy equipment in the shop that may need additional support or restraint. Brace tops of tall narrow equipment taller than 6 feet to nearest backing wall, provide overturning base restraint.

Figure 1-5. Naches Valley HS Voc Tech shop

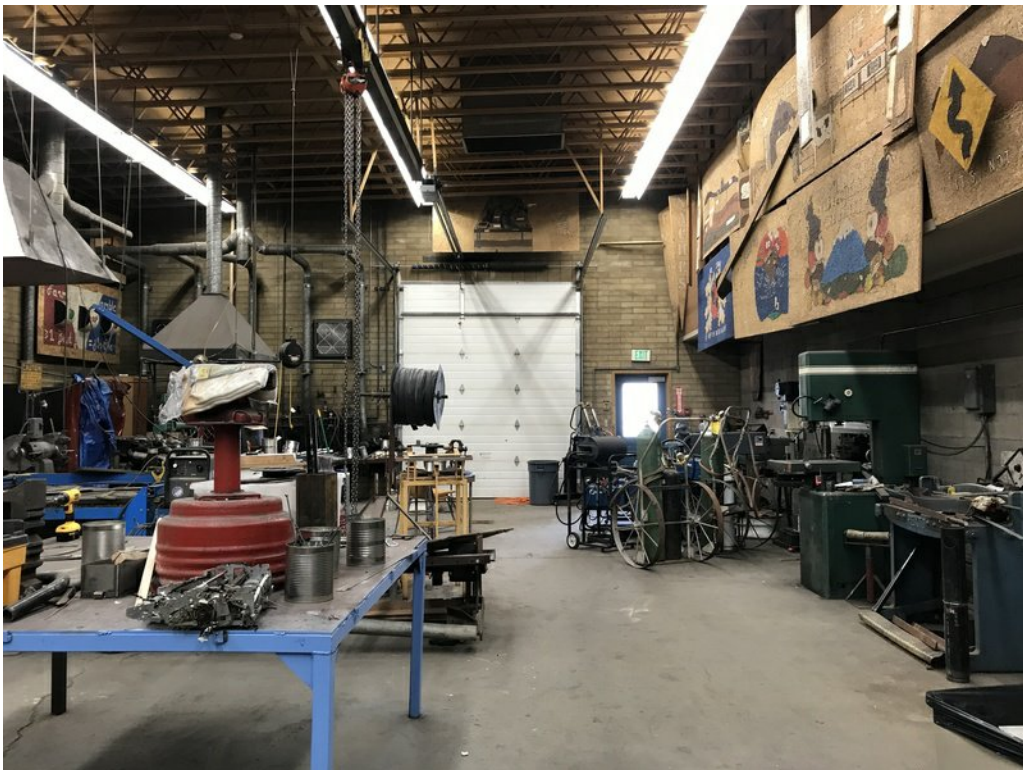
Figure 1-6. Naches Valley HS Voc Tech shop

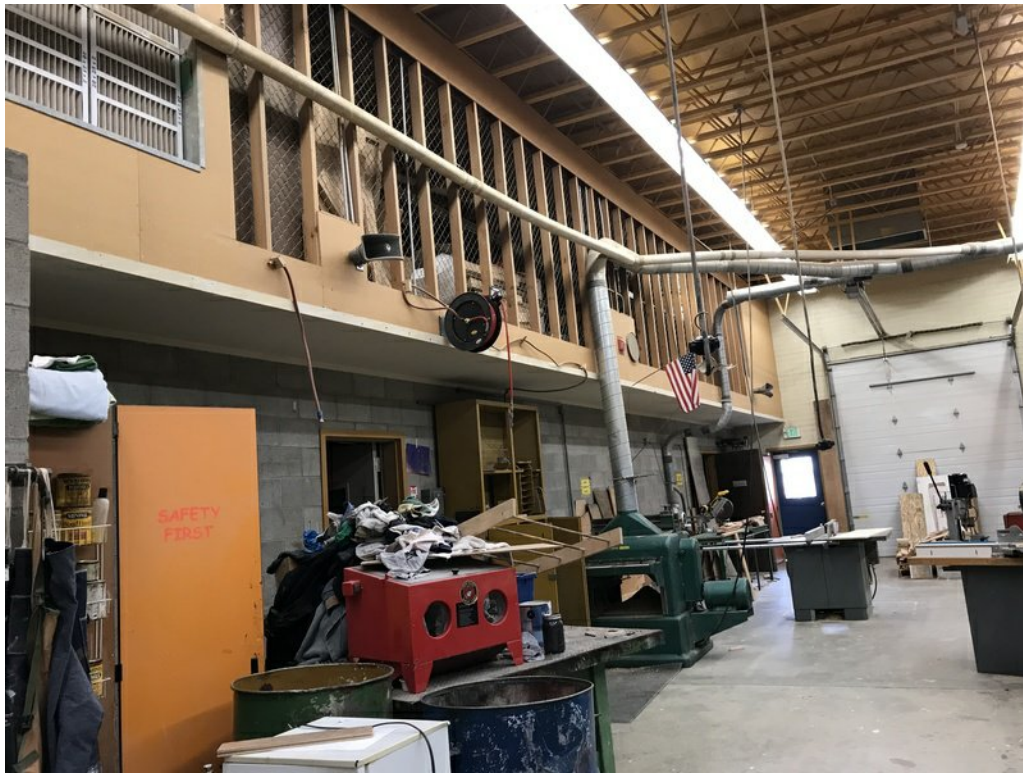
Figure 1-7. Naches Valley HS Voc Tech mezzanine

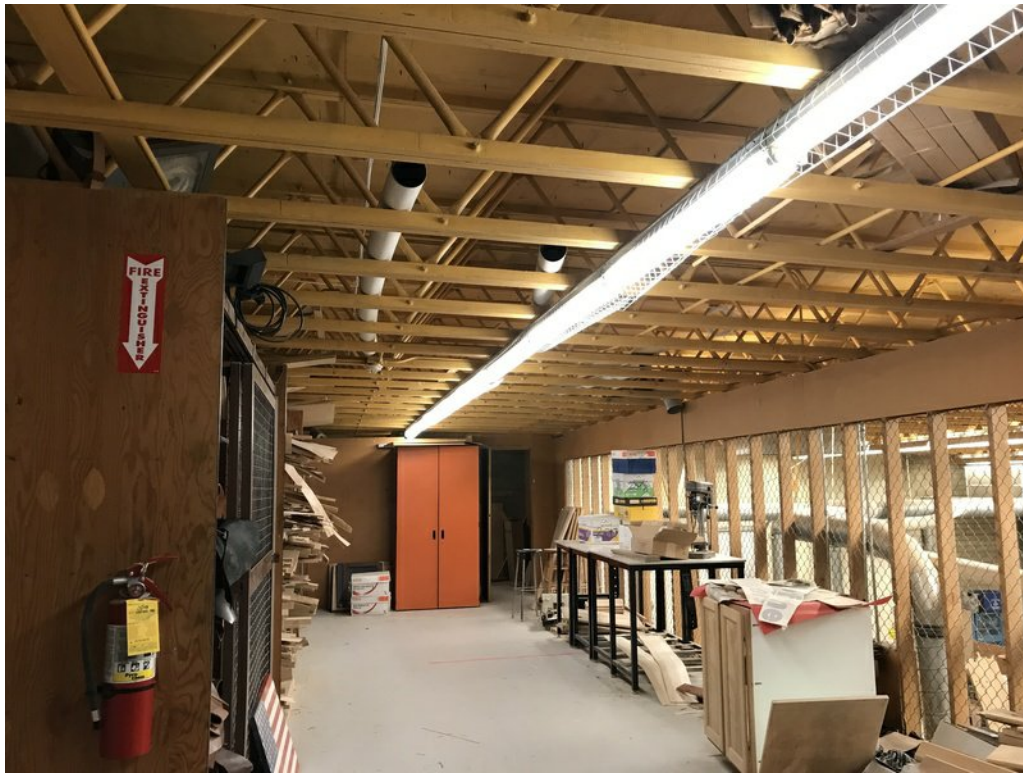
Figure 1-9. Naches Valley HS Voc Tech mezzanine

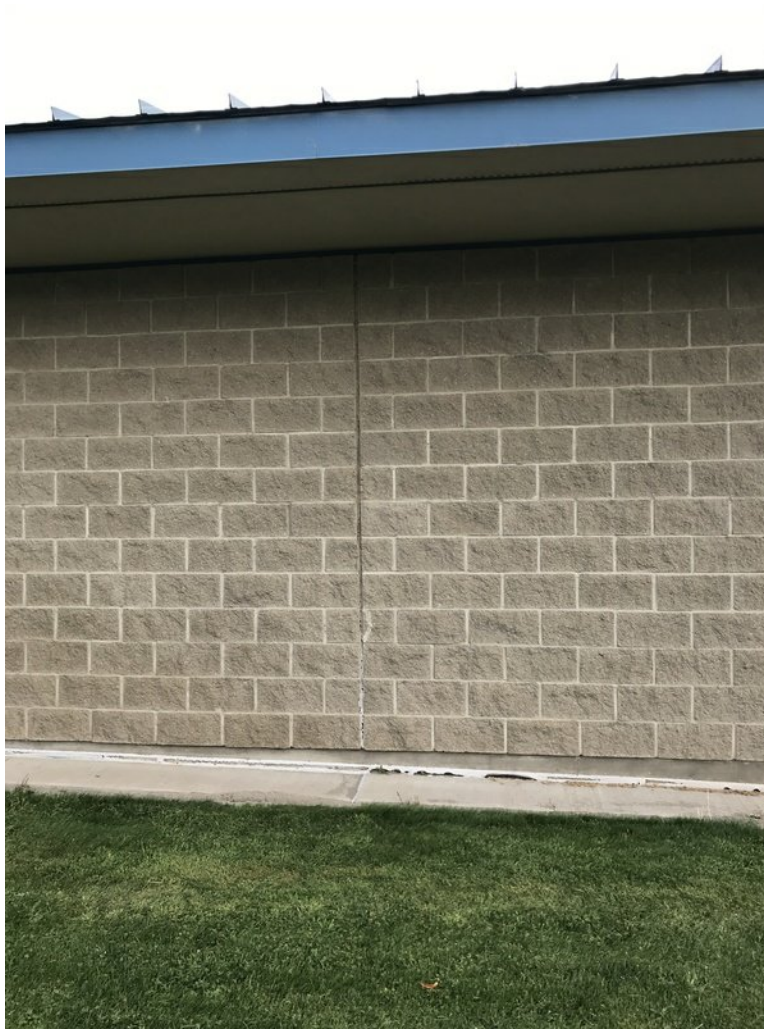
Figure 1-3. control joint at masonry wall construction

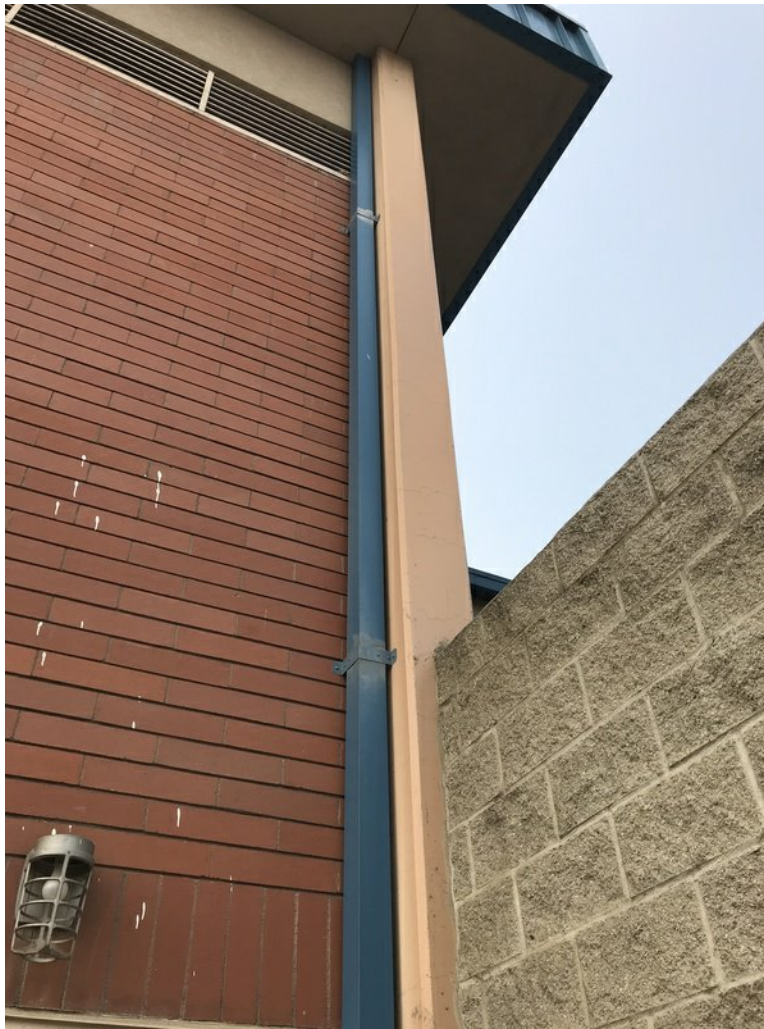
Figure 1-7. Naches Valley MS Gym/classroom joint
